FINAL REPORT OF SPECIFIC PURPOSE LIDAR SURVEY

LiDAR-Generated Breaklines and Contours for Flagler County, Florida

State of Florida
Division of Emergency Management
Contract 07-HS-34-14-00-22-469
Task Order 200712004-49271
PDS Task Order D

November 18, 2008

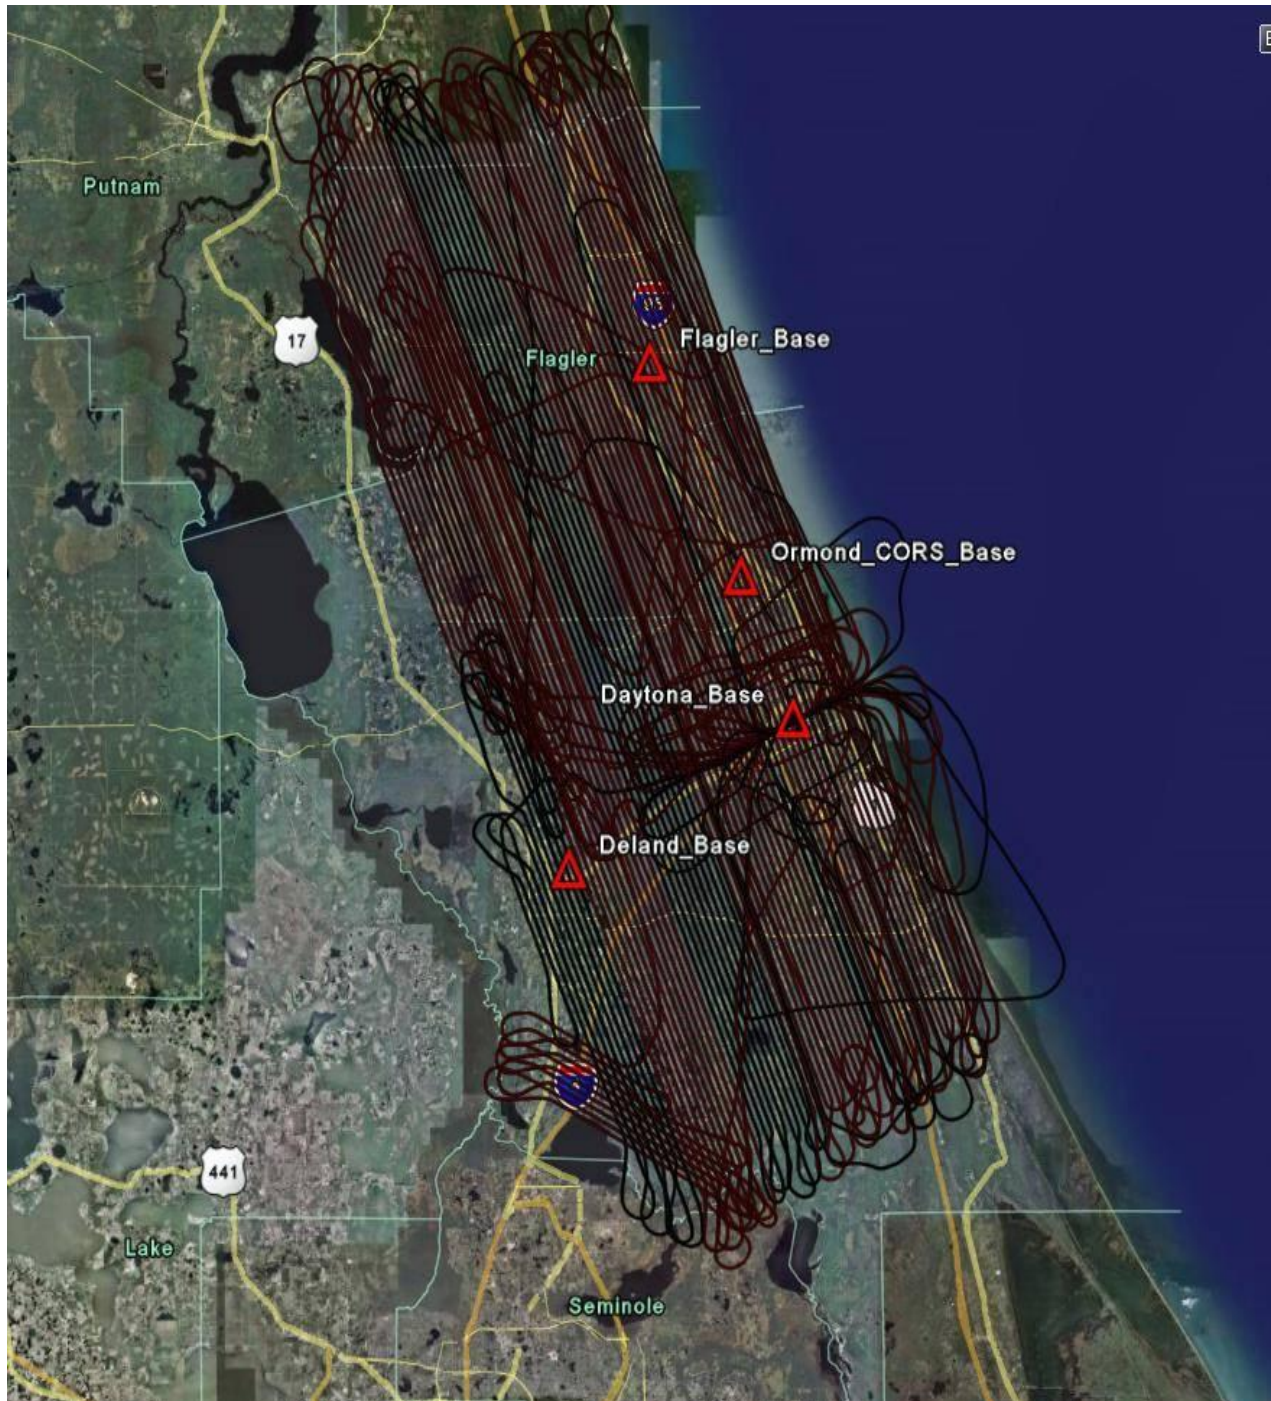
Flight Diagram for the Daytona Beach Project showing Actual Flight Lines and Base Station Locations

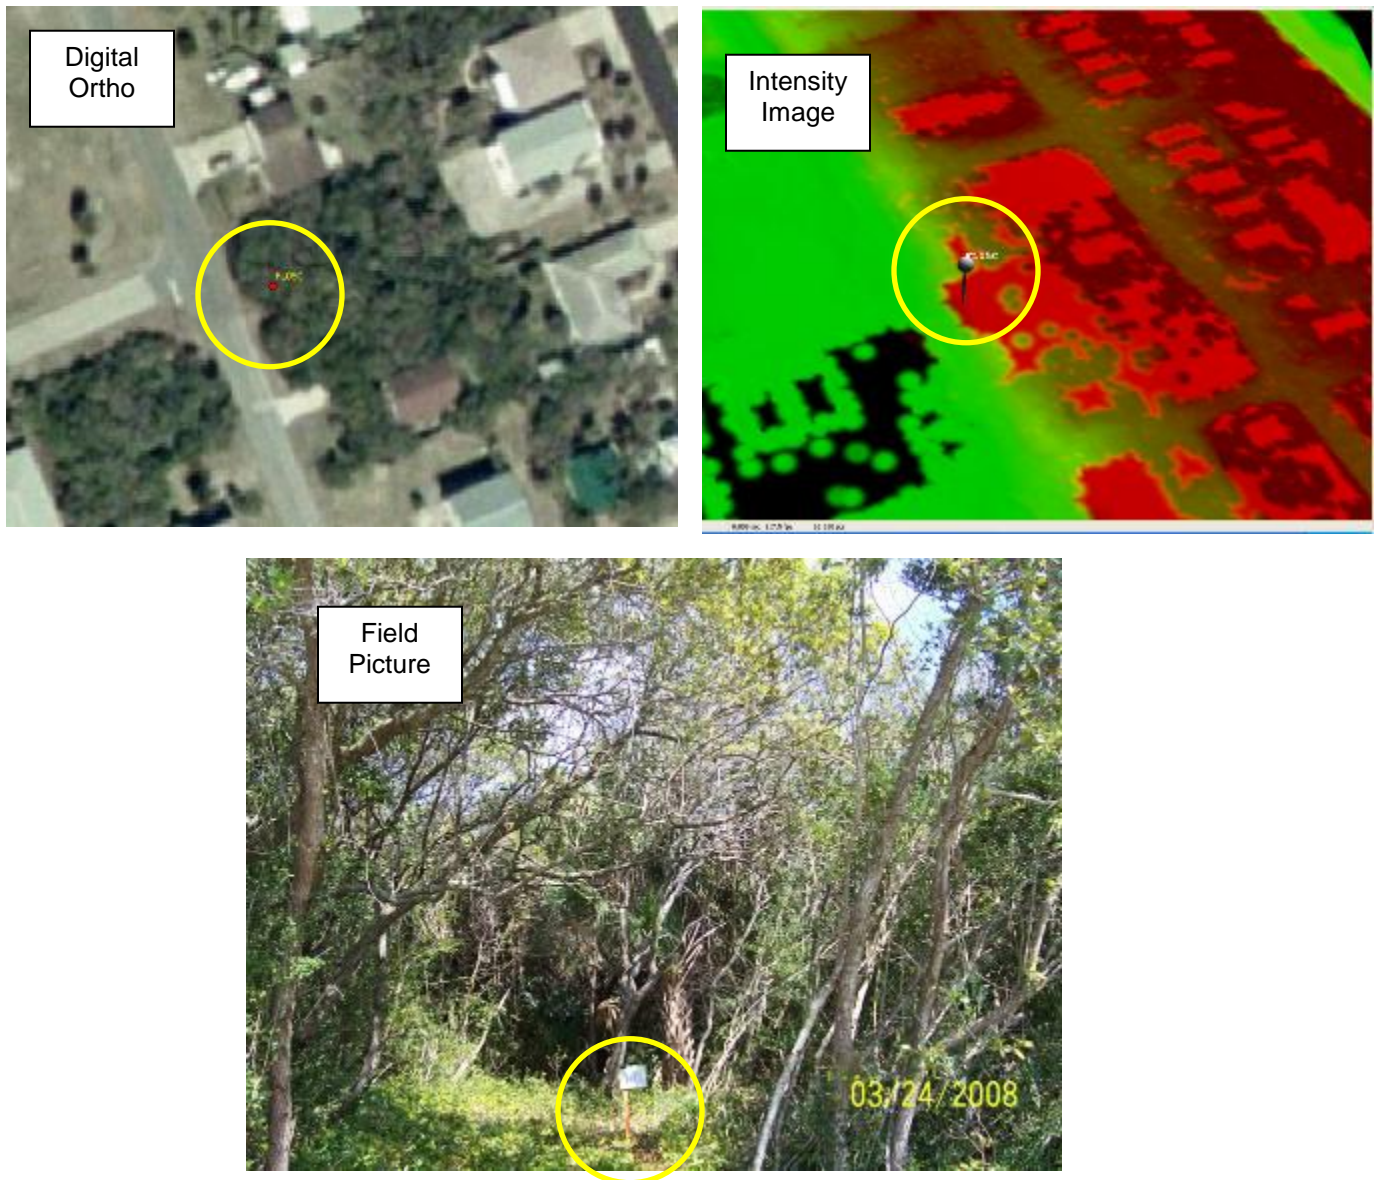
Figure 6 shows CAT 3 – Forested checkpoint FL05C digital ortho image and the density grid image, side-by-side, with the picture captured in the field underneath. The density grids were generated at a default cell size of 4 ft. “Dense” data is color green; dense is defined as a data point with an adjacent point equal to or less than the selected grid spacing of 4 ft. Sparse data is colored red; dense data is defined a point with the closest adjacent point greater than four times the selected grid spacing of 4 ft.

Figure 6 — Checkpoint FL05C Digital Ortho, Intensity Image and Field Picture

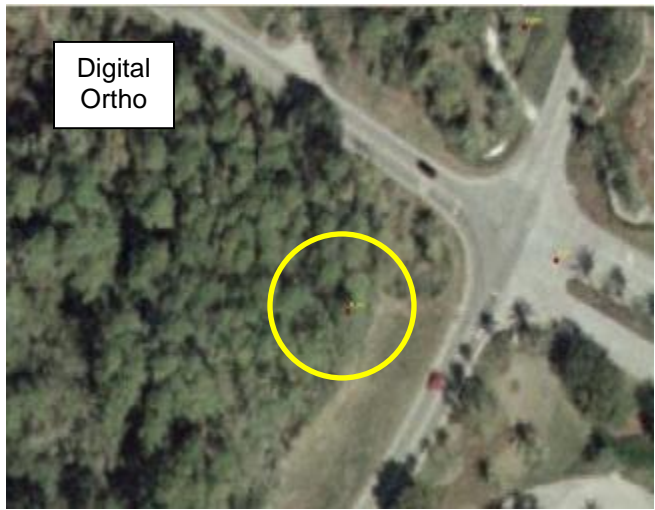
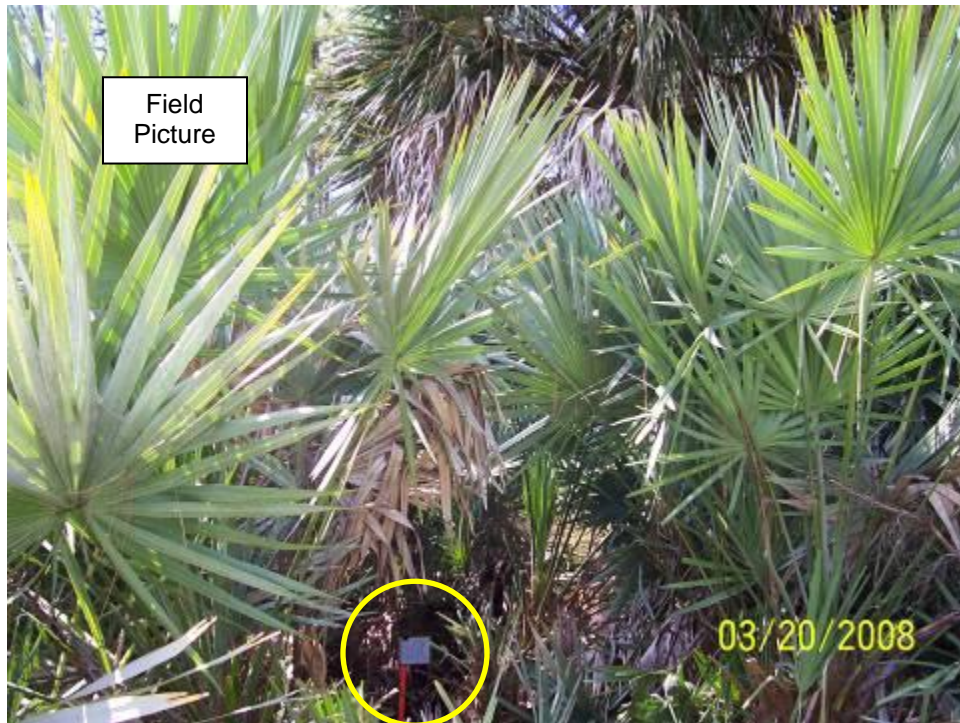
Figure 7 — Checkpoint FL07C Digital Ortho, Intensity Image and Field Picture

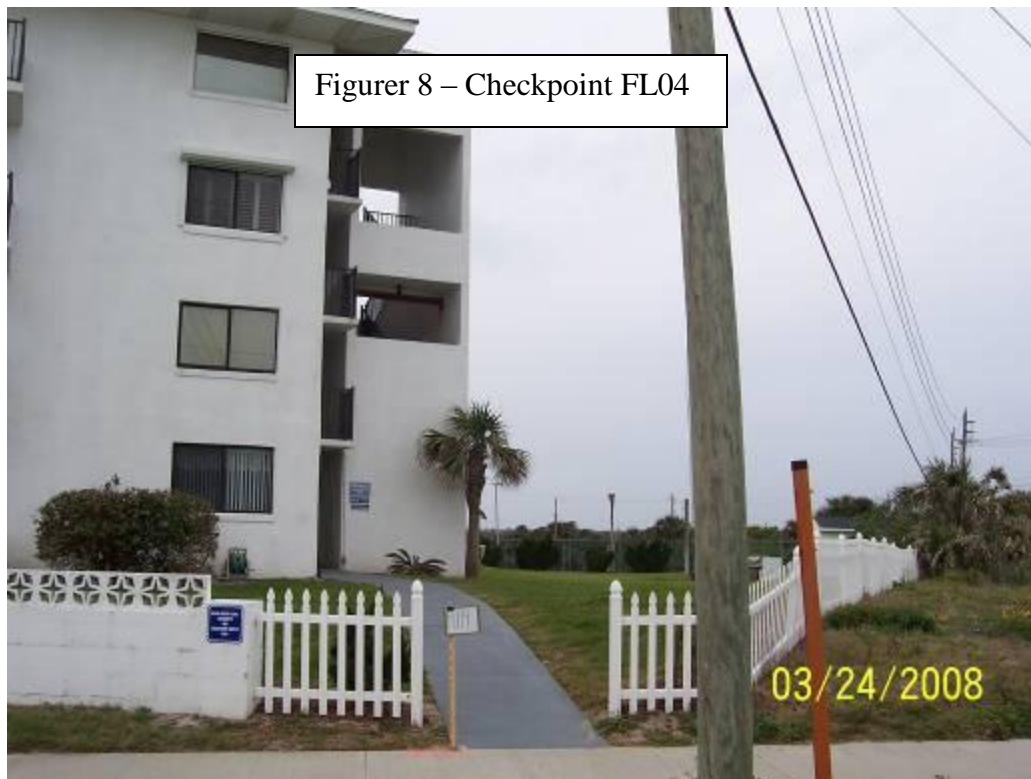
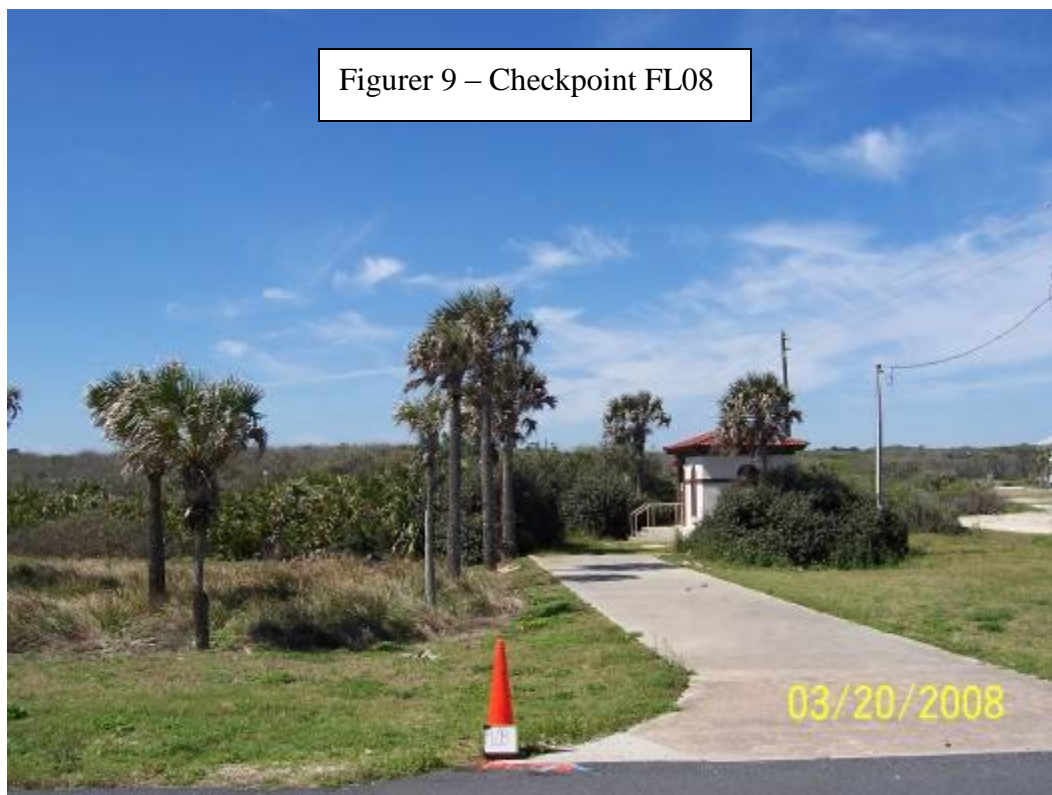
Figures 8 & 9 shows Ortho Checkpoints FL04 and FL08 that were included in the CAT 1 BE & Low Grass land cover category. These points generally meet the criterion for BE checkpoints.

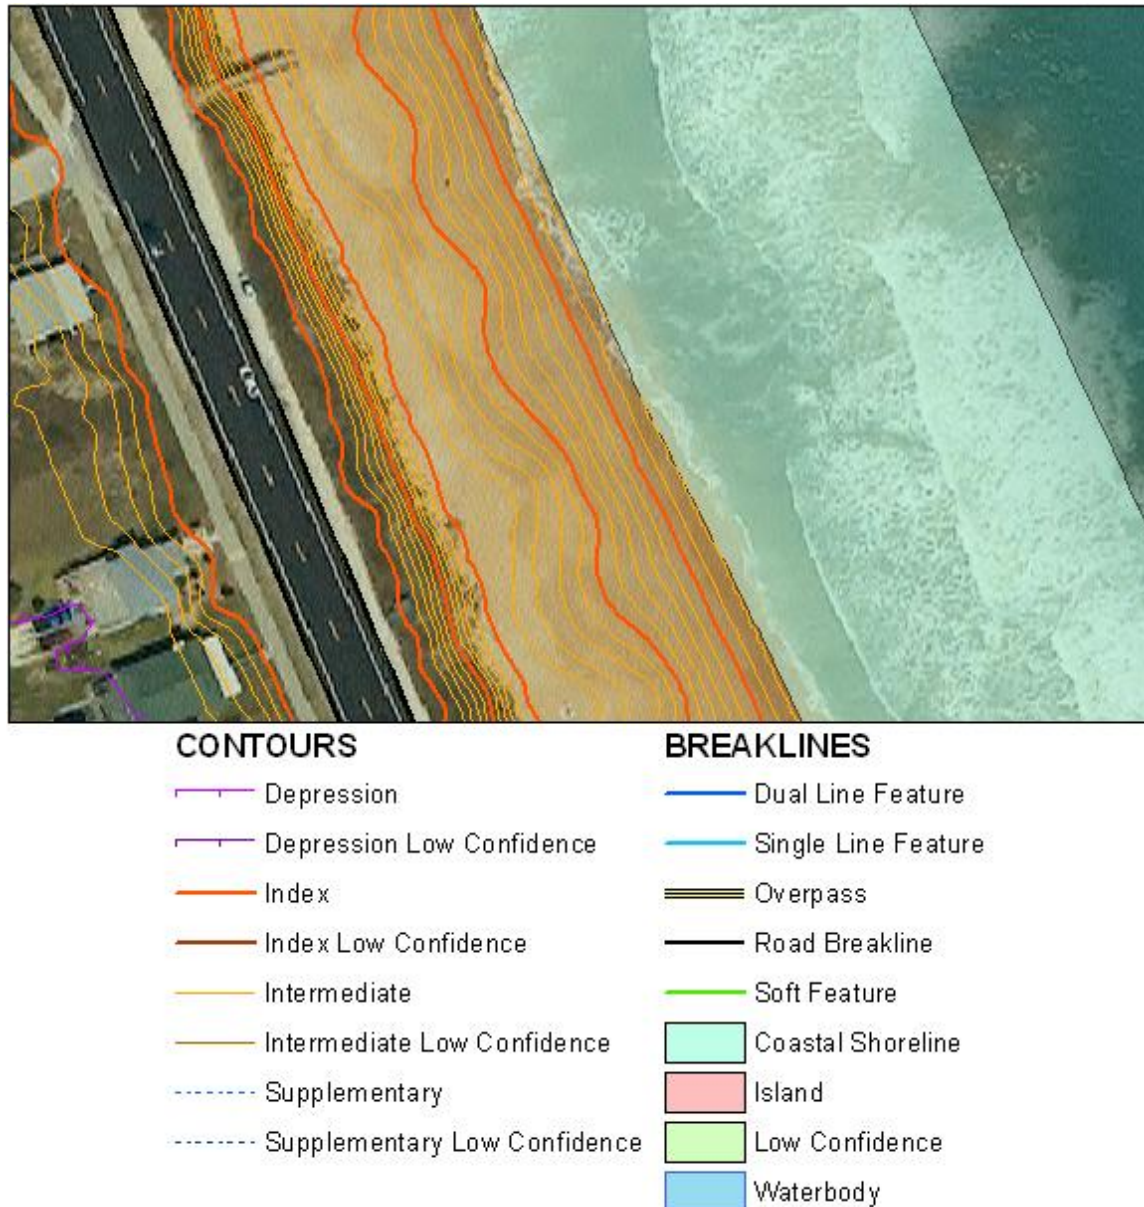
Coastal shorelines are correctly captured as two-dimensional polygon features, extracted from the LiDAR data and not from digital orthophotos, except for manmade features with varying heights such as seawalls which are captured as three-dimensional breaklines. Coastal breaklines merge seamlessly with linear hydrographic features. Shorelines continue beneath docks and piers. There is no “stair-stepping” of coastal shorelines. Figure 1 shows example coastal breaklines and contours.

Figure 1. Example coastal breaklines and contours from tile #37990
